DOT HS 806 842

Final Report

September 1984

Side-Impact Aggressiveness Attributes MDB-To-Car Side Impact Test of a 19° Crabbed Moving Deformable Barrier to a 1981 Volkswagen Rabbit at 46.4 Mph

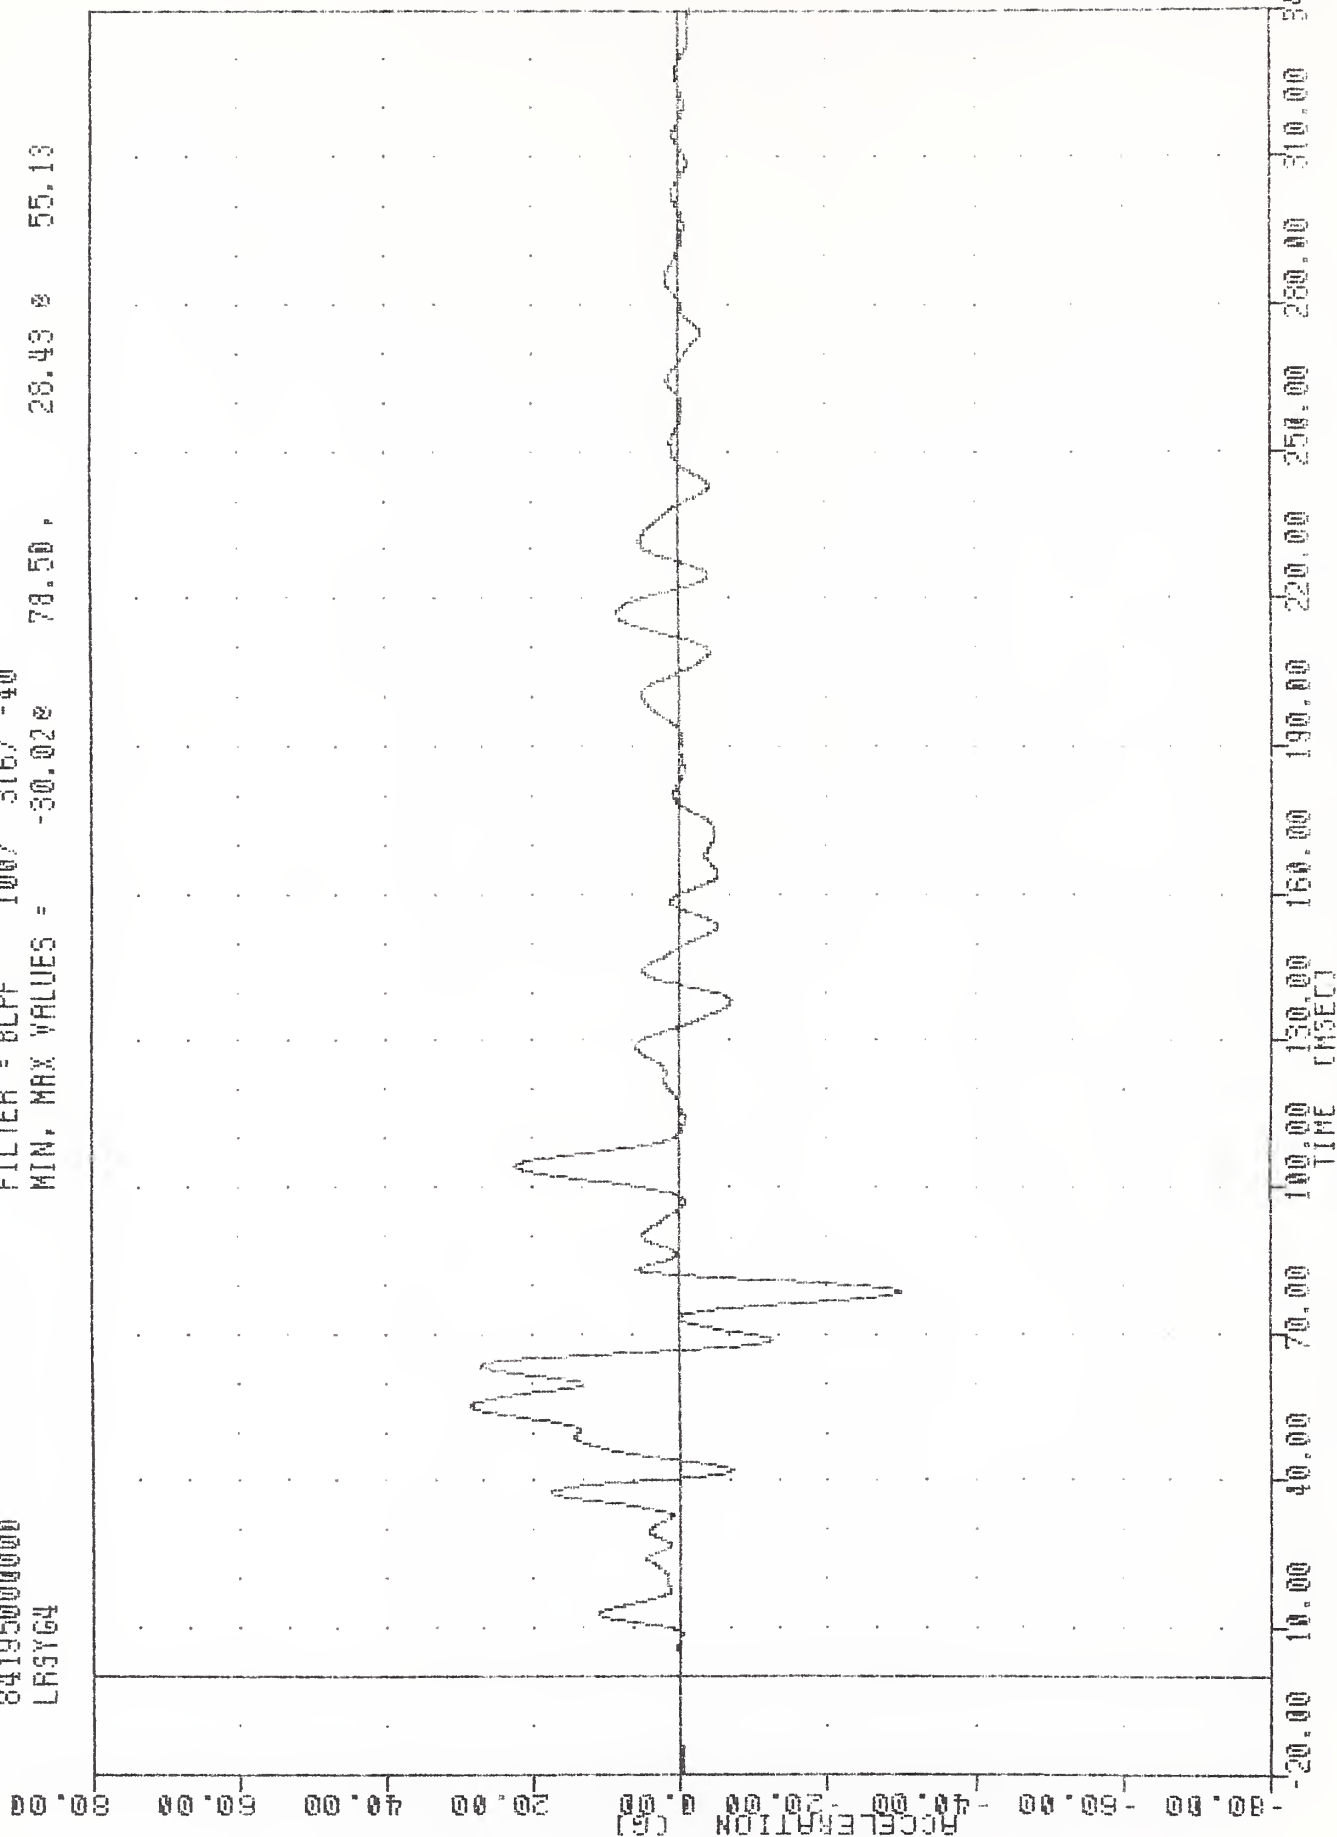
MOVING DEFORMABLE BARRIER INTO VOLKSWAGEN RABBIT
 VEHICLE LEFT REAR SILL ACCELERATION Y AXIS

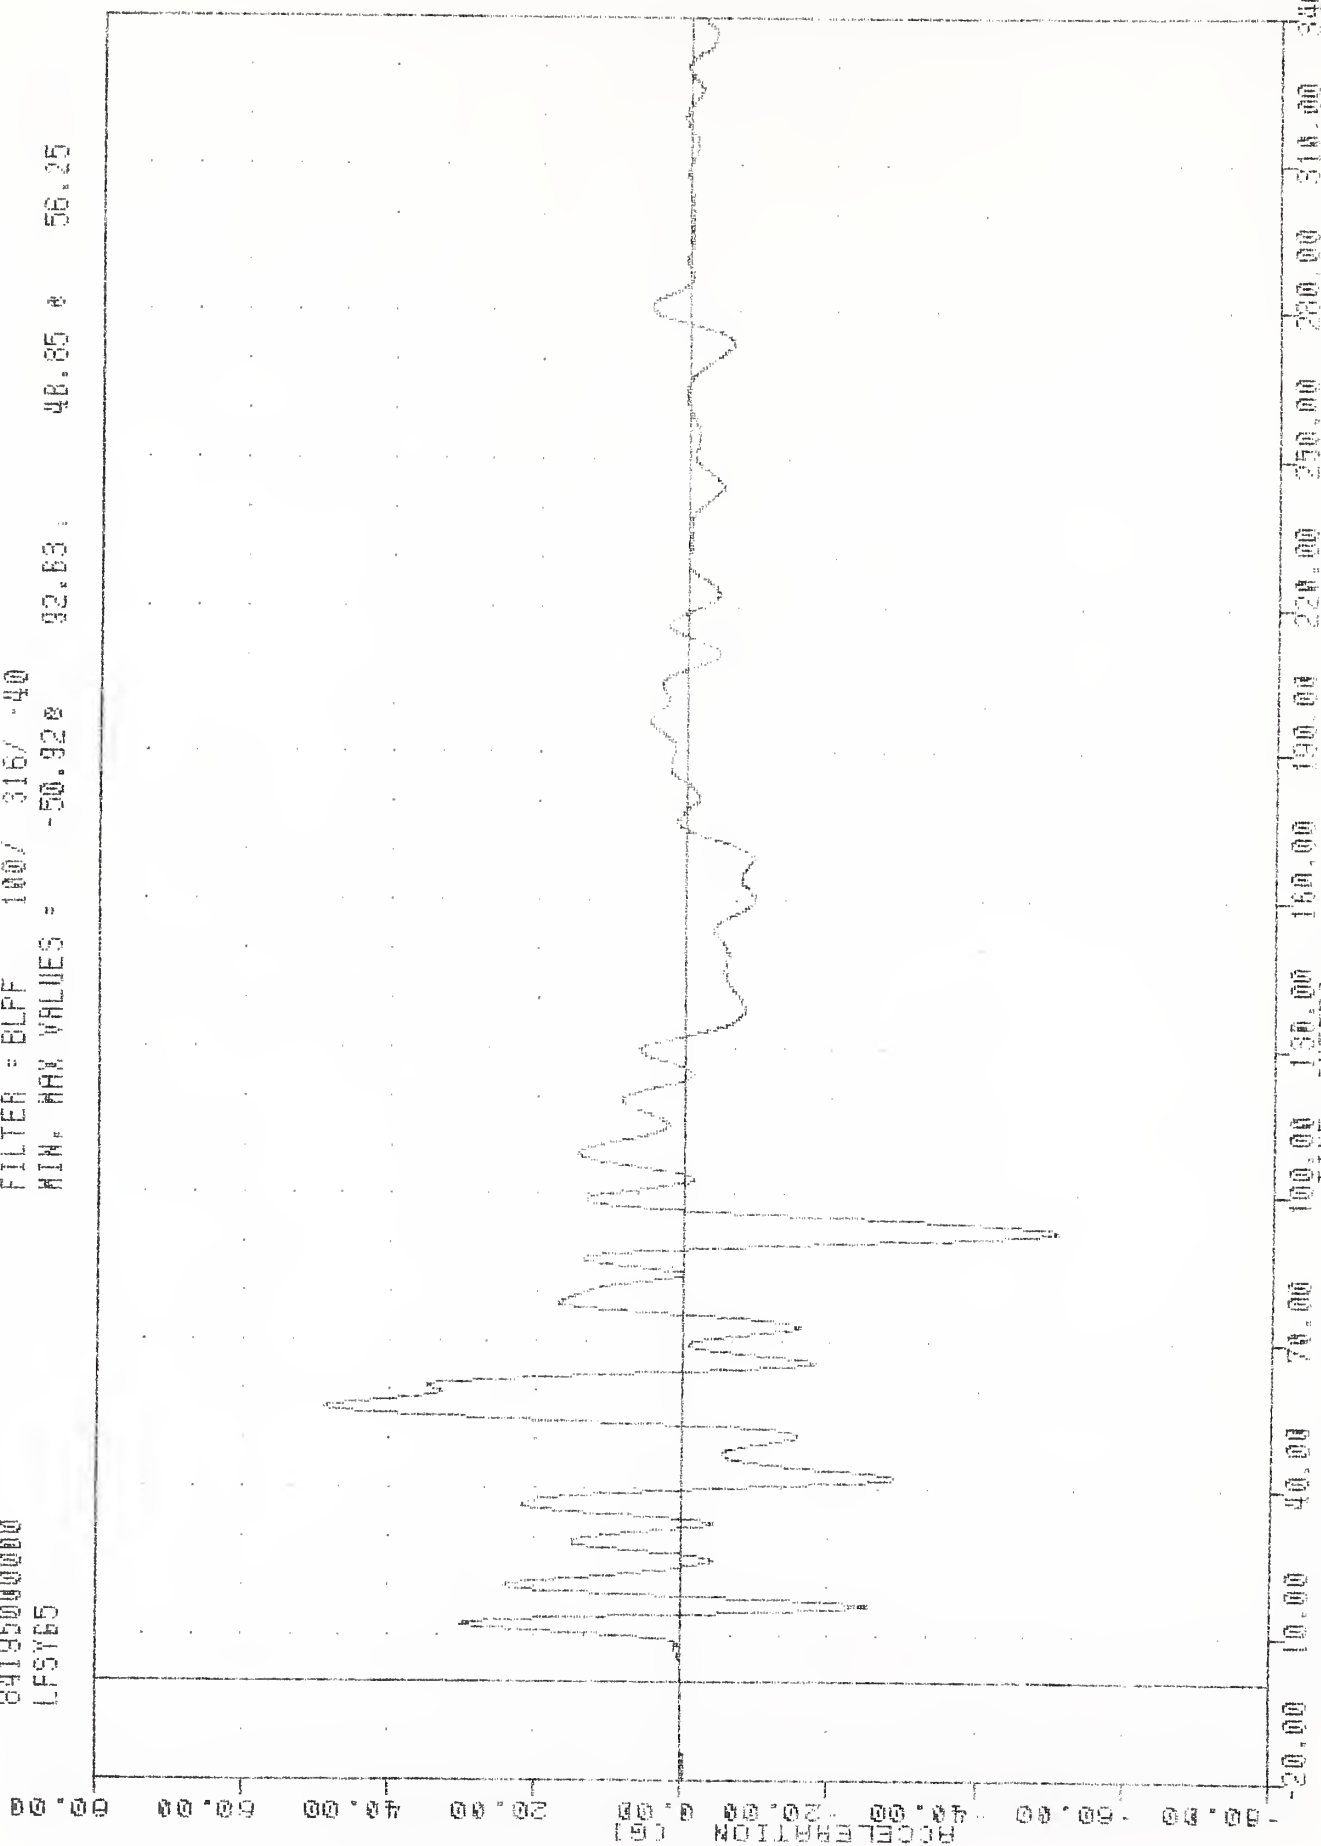
MOVING DEFORMABLE BARRIER INTO VOLKSWAGEN RABBIT
 VEHICLE LEFT FRONT SILL ACCELERATION Y AXIS

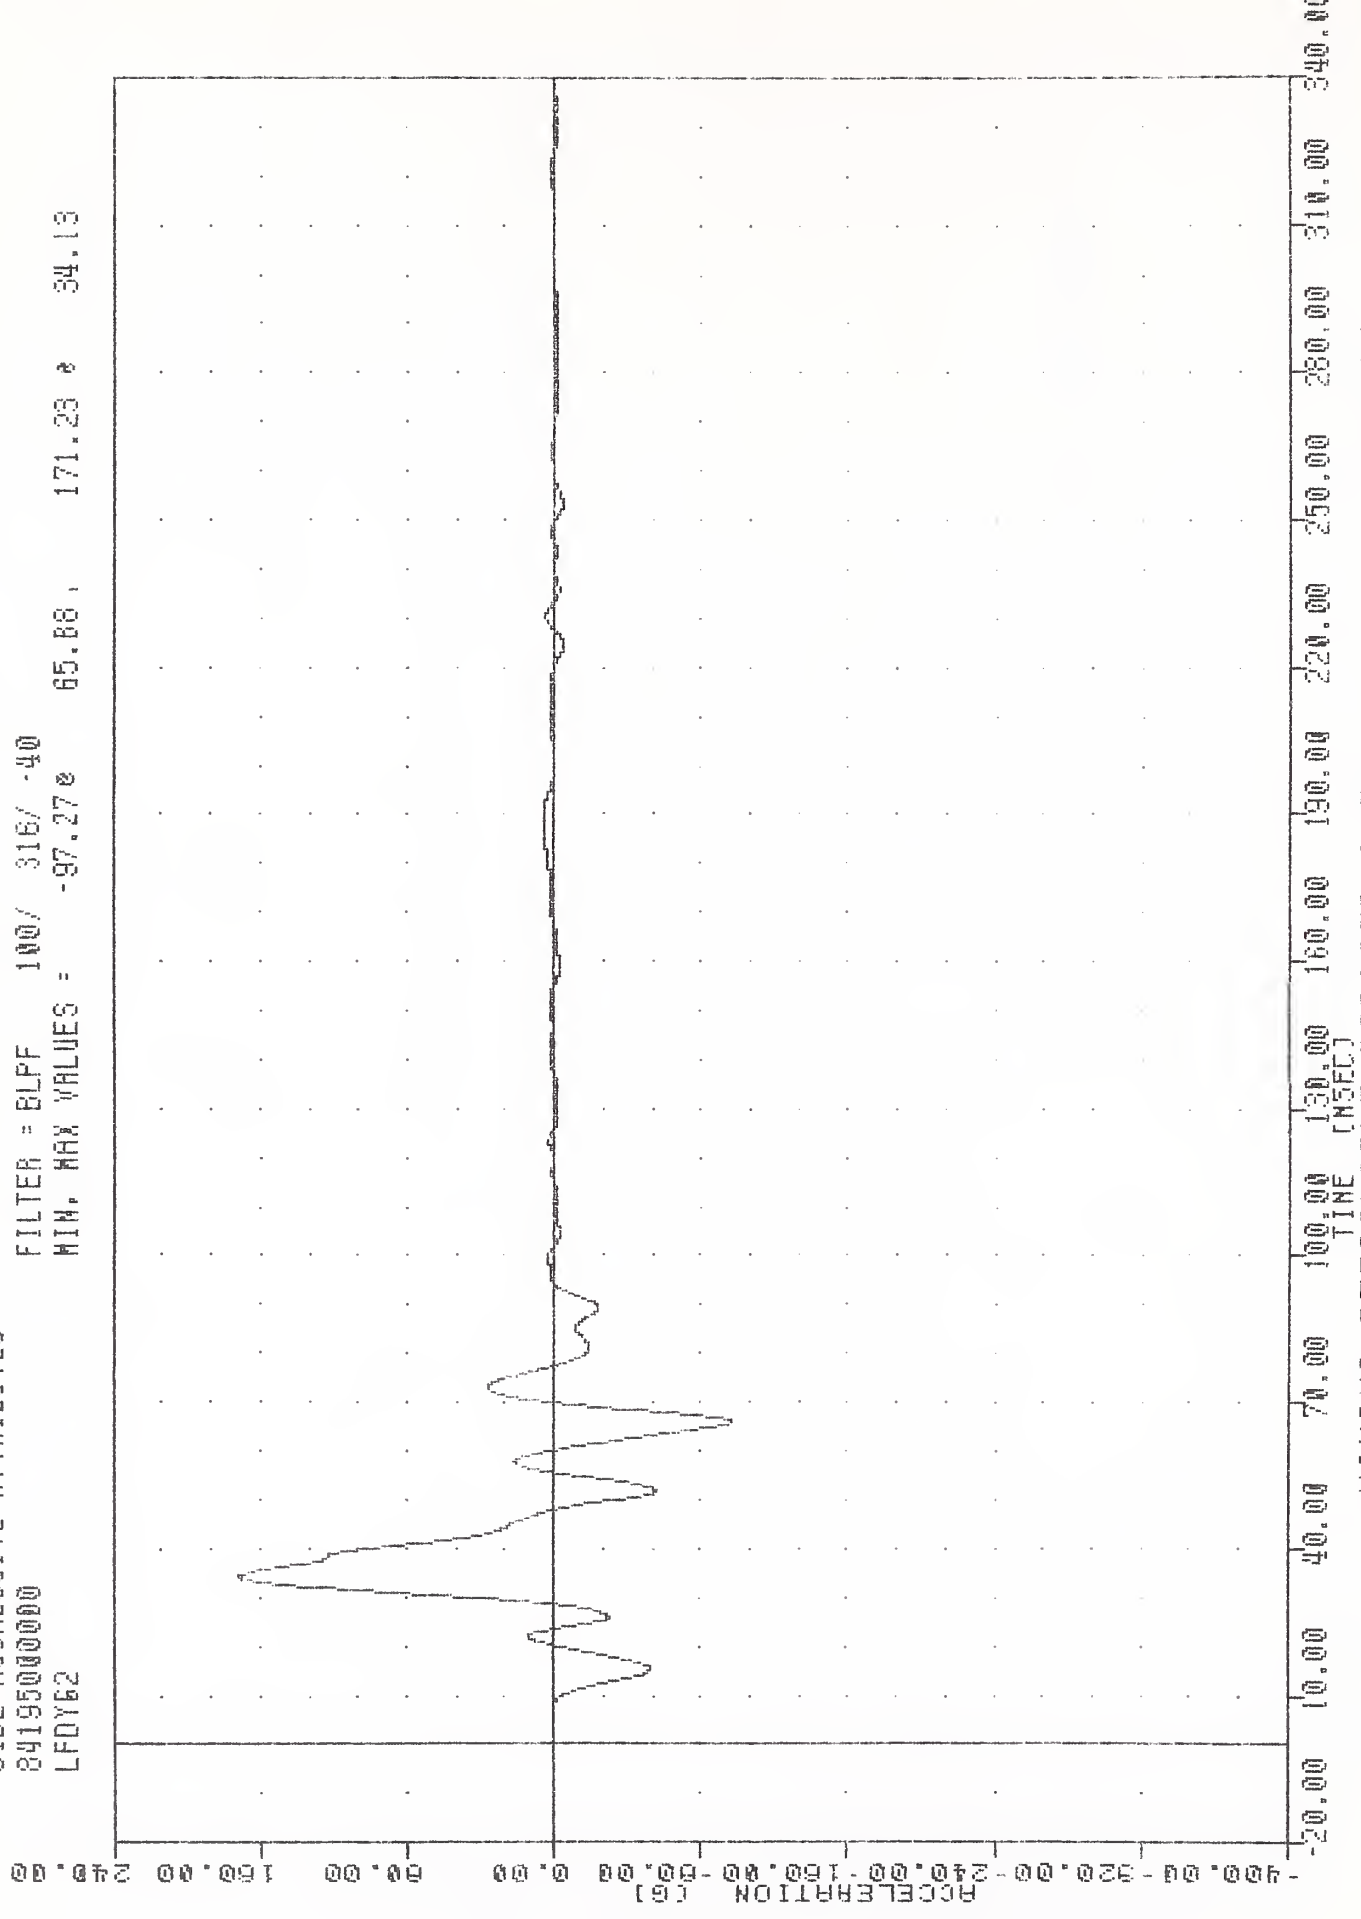
MOVING DEFORMABLE BARRIER INTO VOLKSWAGEN RABBIT
VEHICLE LEFT FRONT DOOR (POSITION 8) ACCELERATION Y AXIS

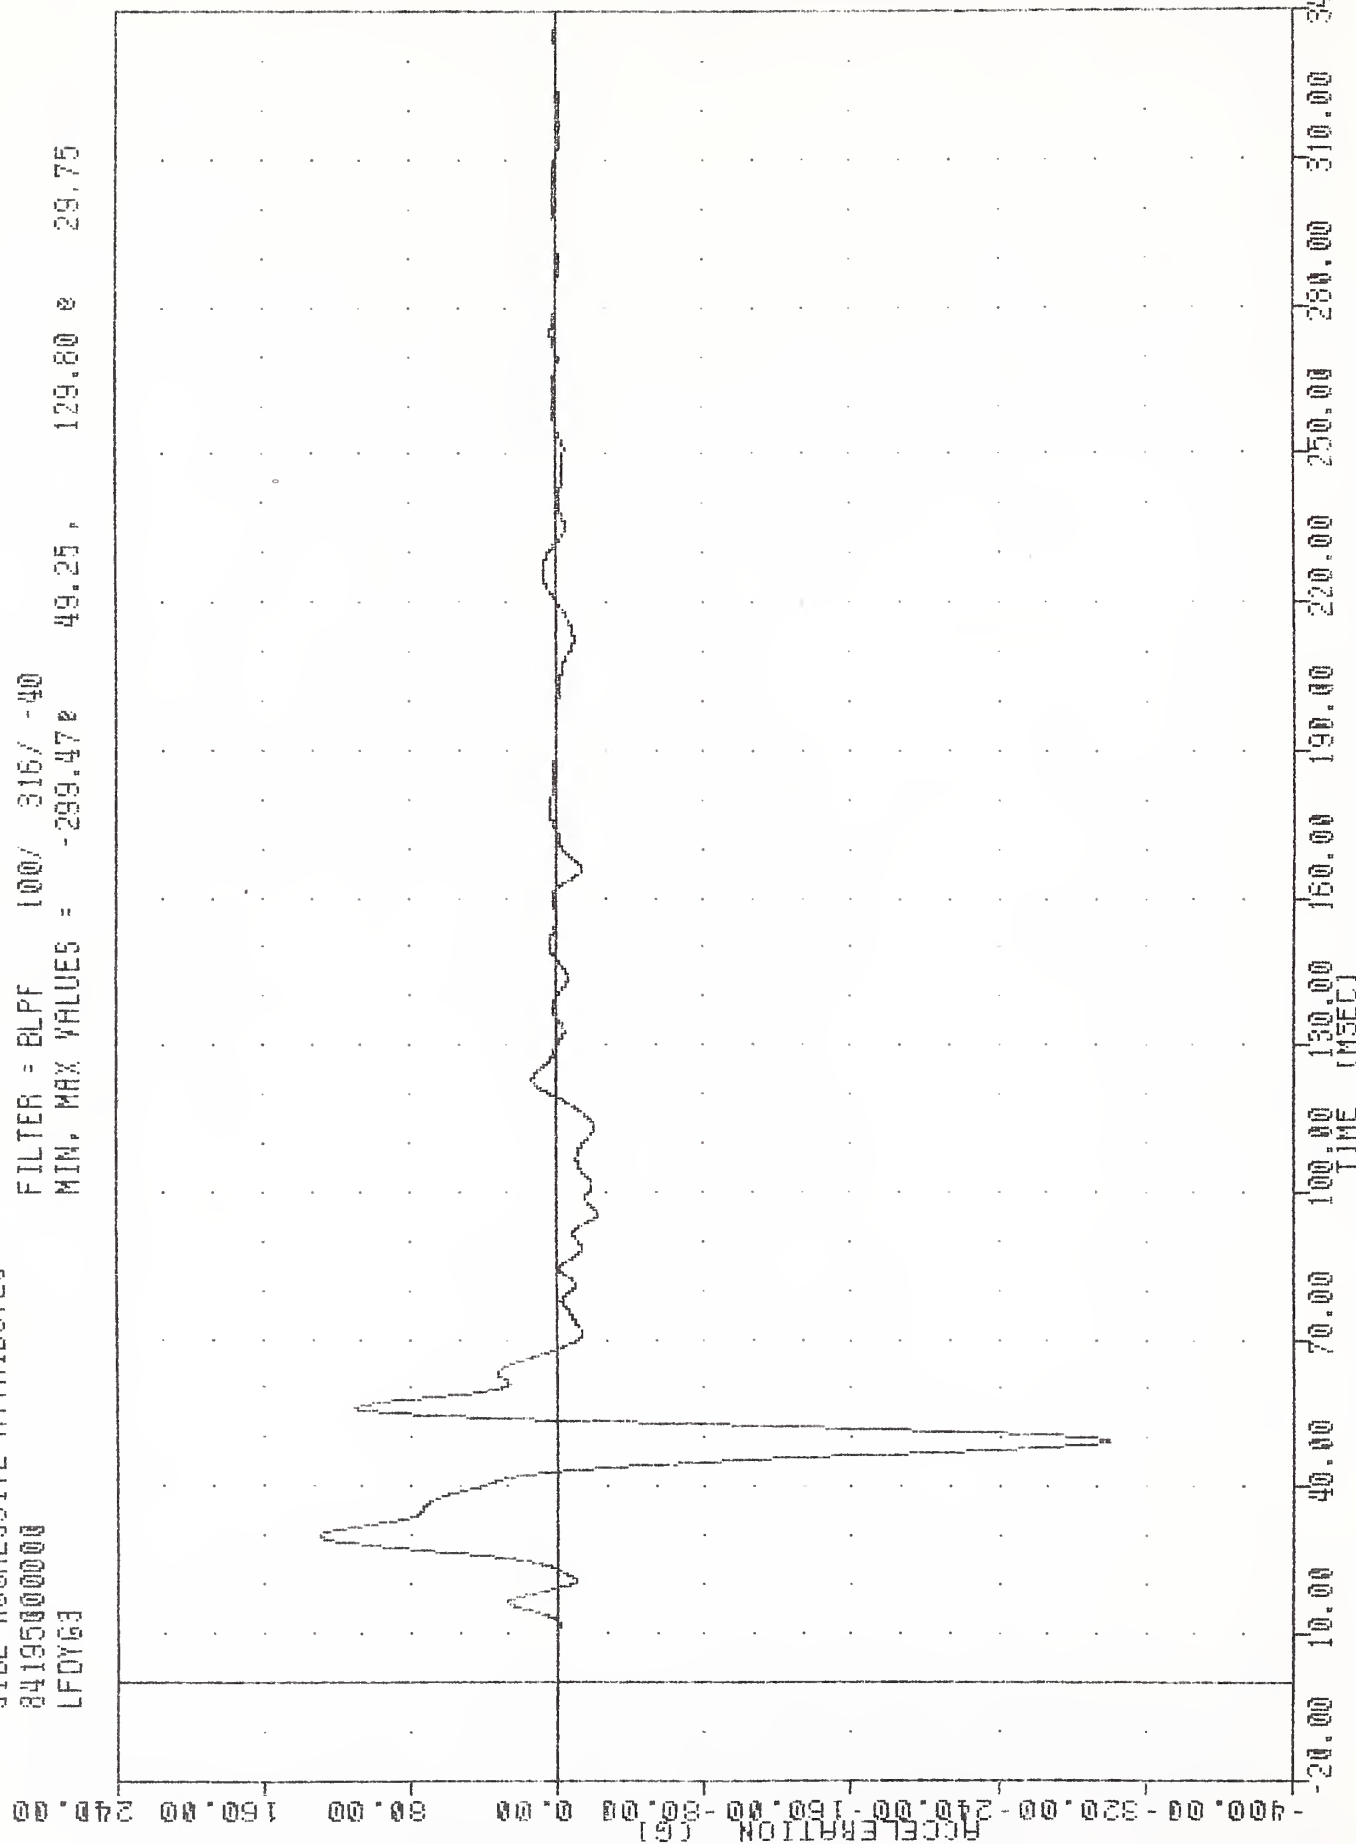
MOVING DEFORMABLE BARRIER INTO VOLKSWAGEN RABBIT
VEHICLE LEFT FRONT DOOR (POSITION 9) ACCELERATION Y AXIS

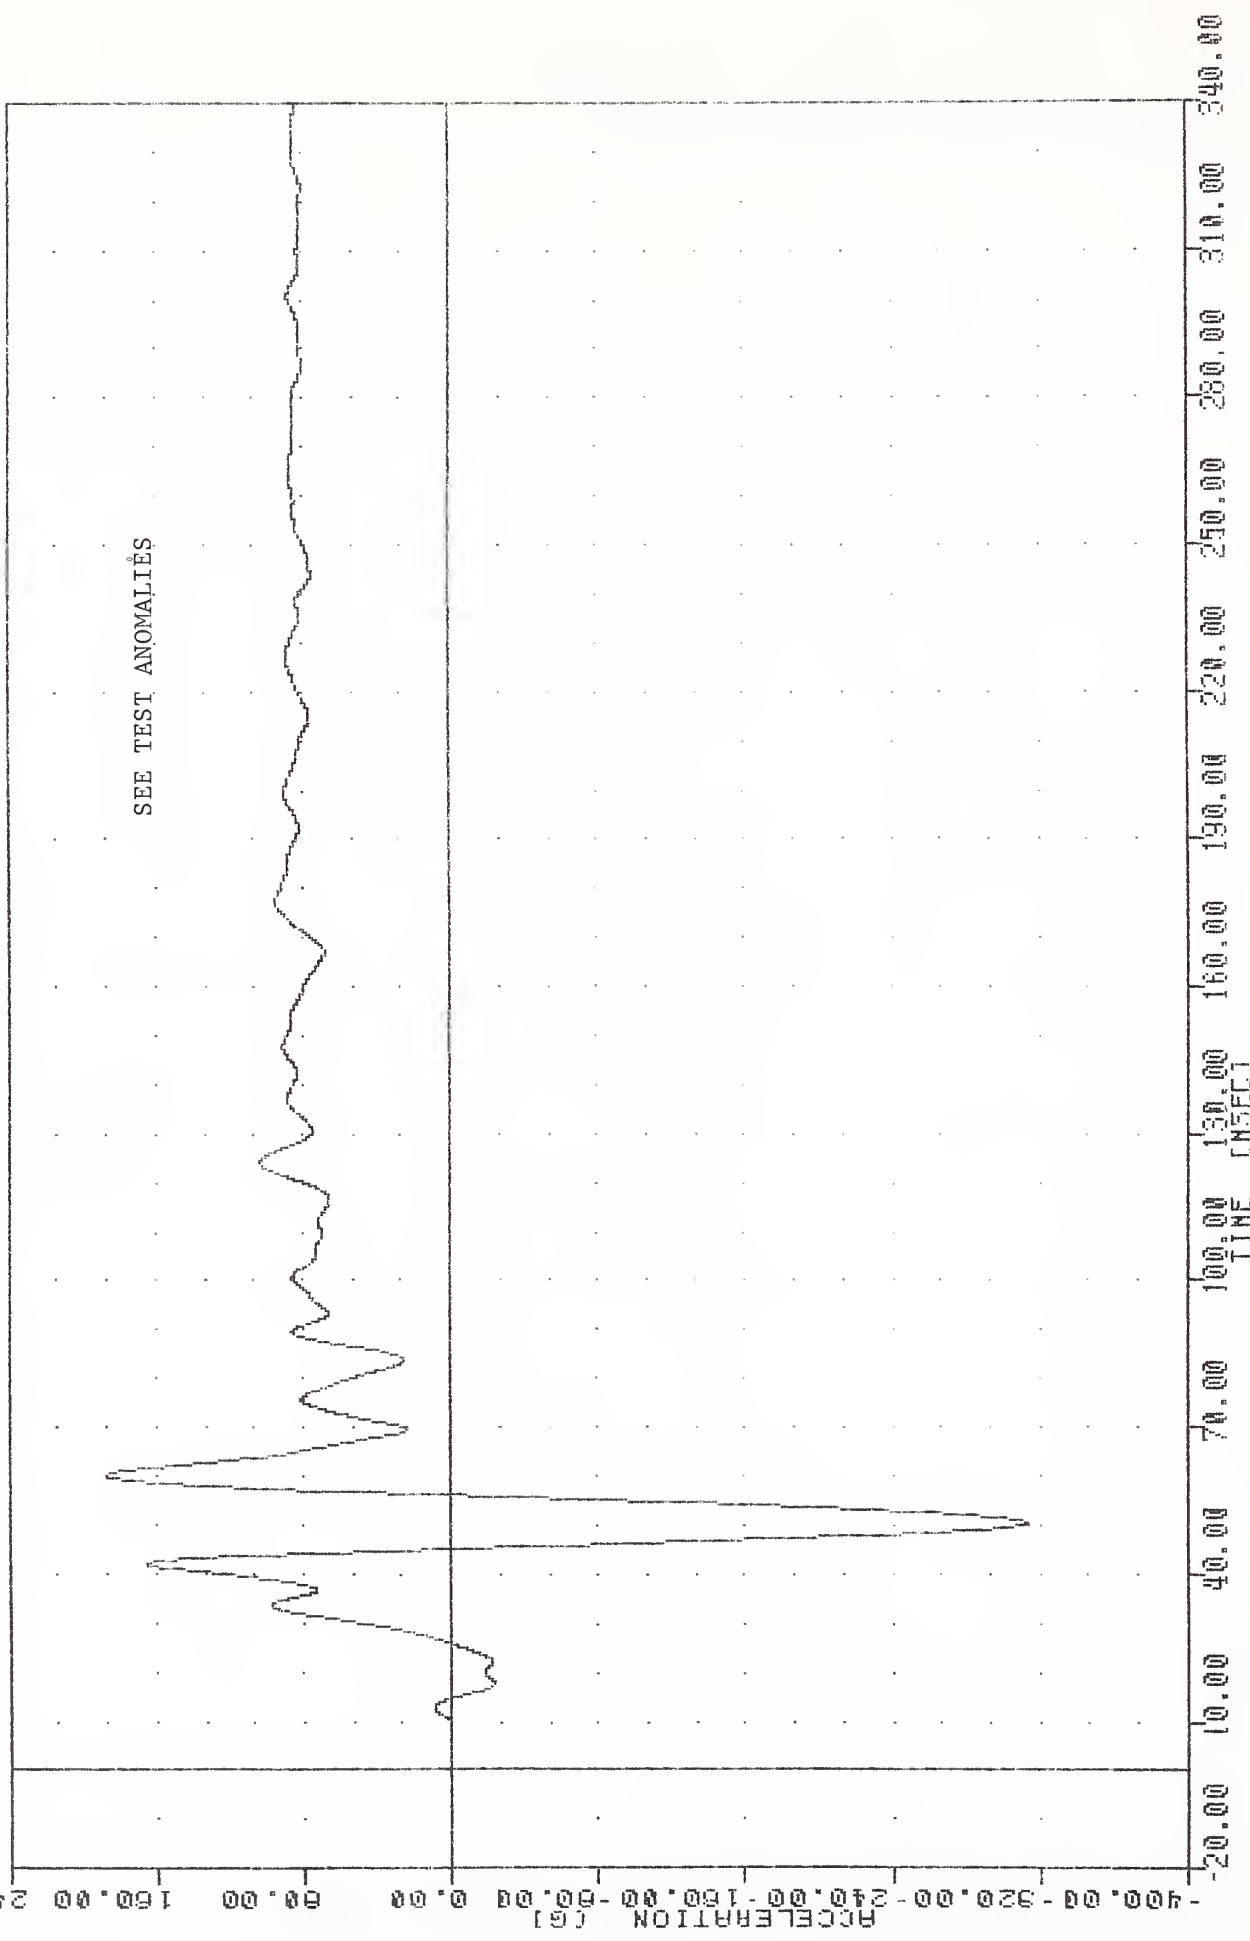
MOVING DEFORMABLE BARRIER INTO VOLKSWAGEN RABBIT
 VEHICLE LEFT FRONT DOOR (POSITION 11) ACCELERATION Y AXIS

The Left Front Door Accelerometer in Position 11, LFDYG5, was found to have a physical problem, possibly due to excessive strain on the front door.

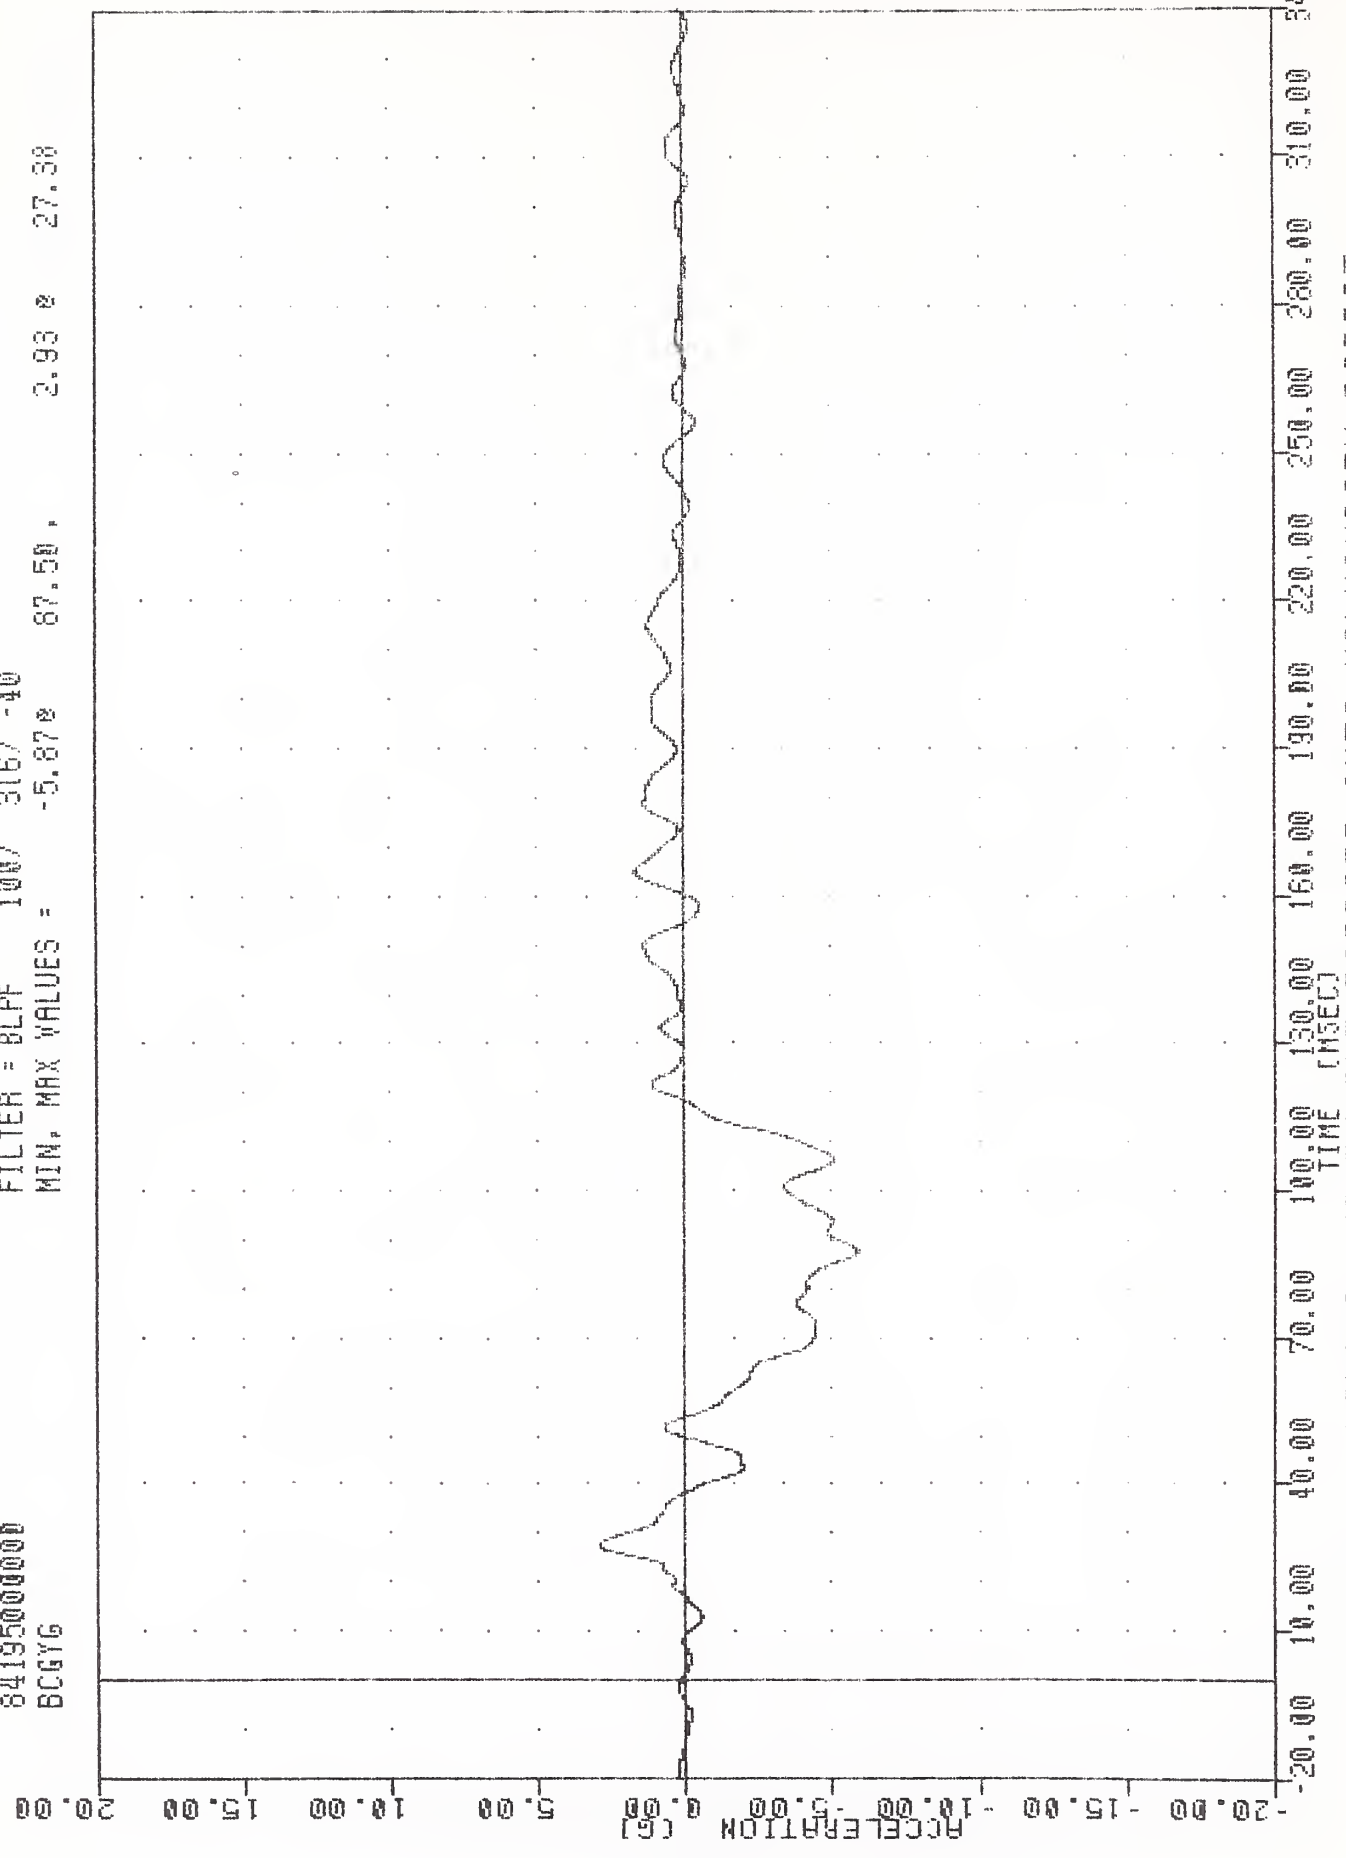
MOVING DEFORMABLE BARRIER INTO VOLKSWAGEN RABBIT
 BARRIER CENTER OF GRAVITY Y AXIS

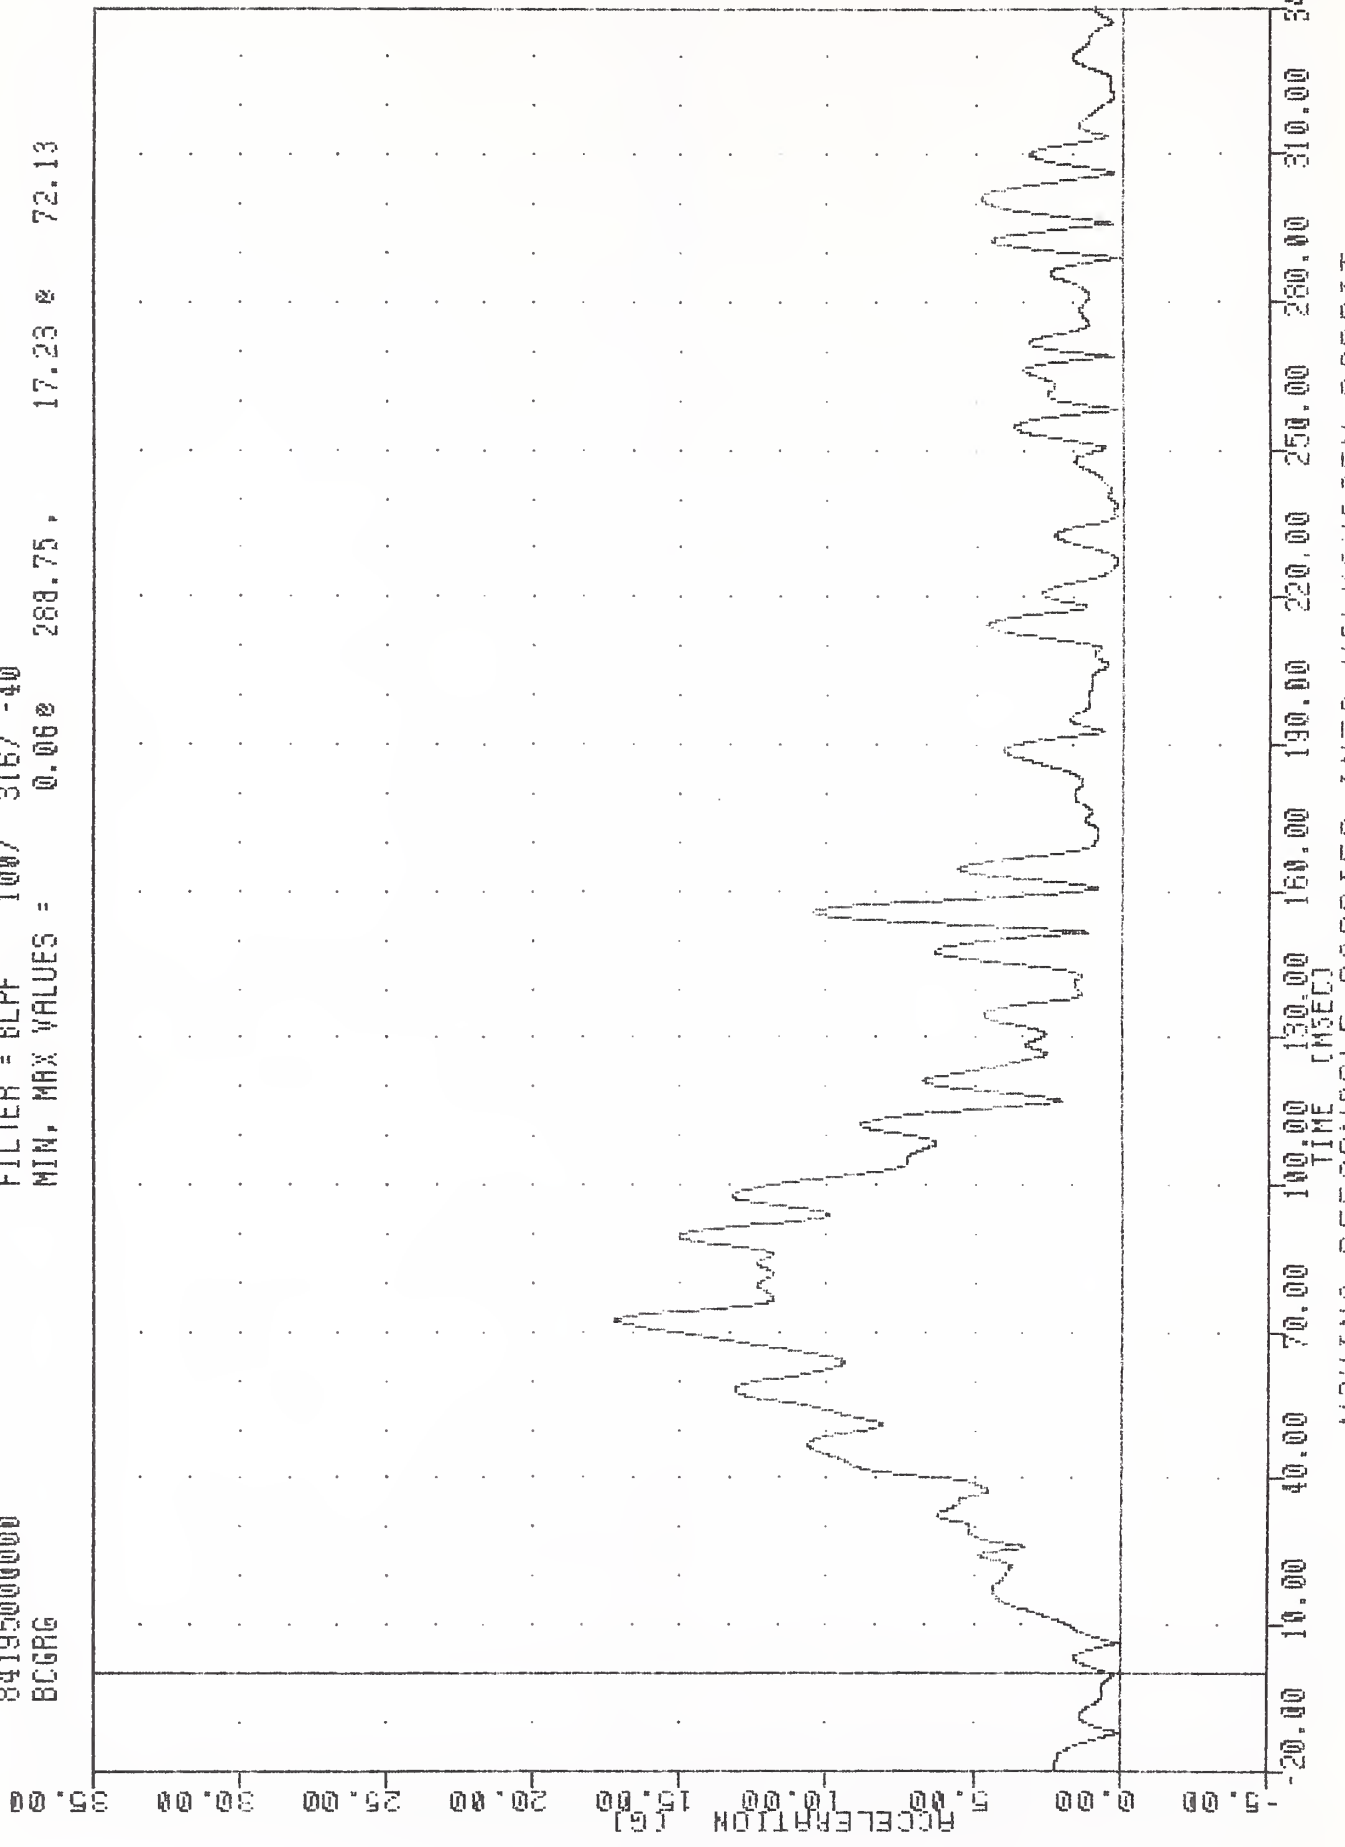
MOVING DEFORMABLE BARRIER INTO VOLKSWAGEN RABBIT
 BARRIER CG RESULTANT

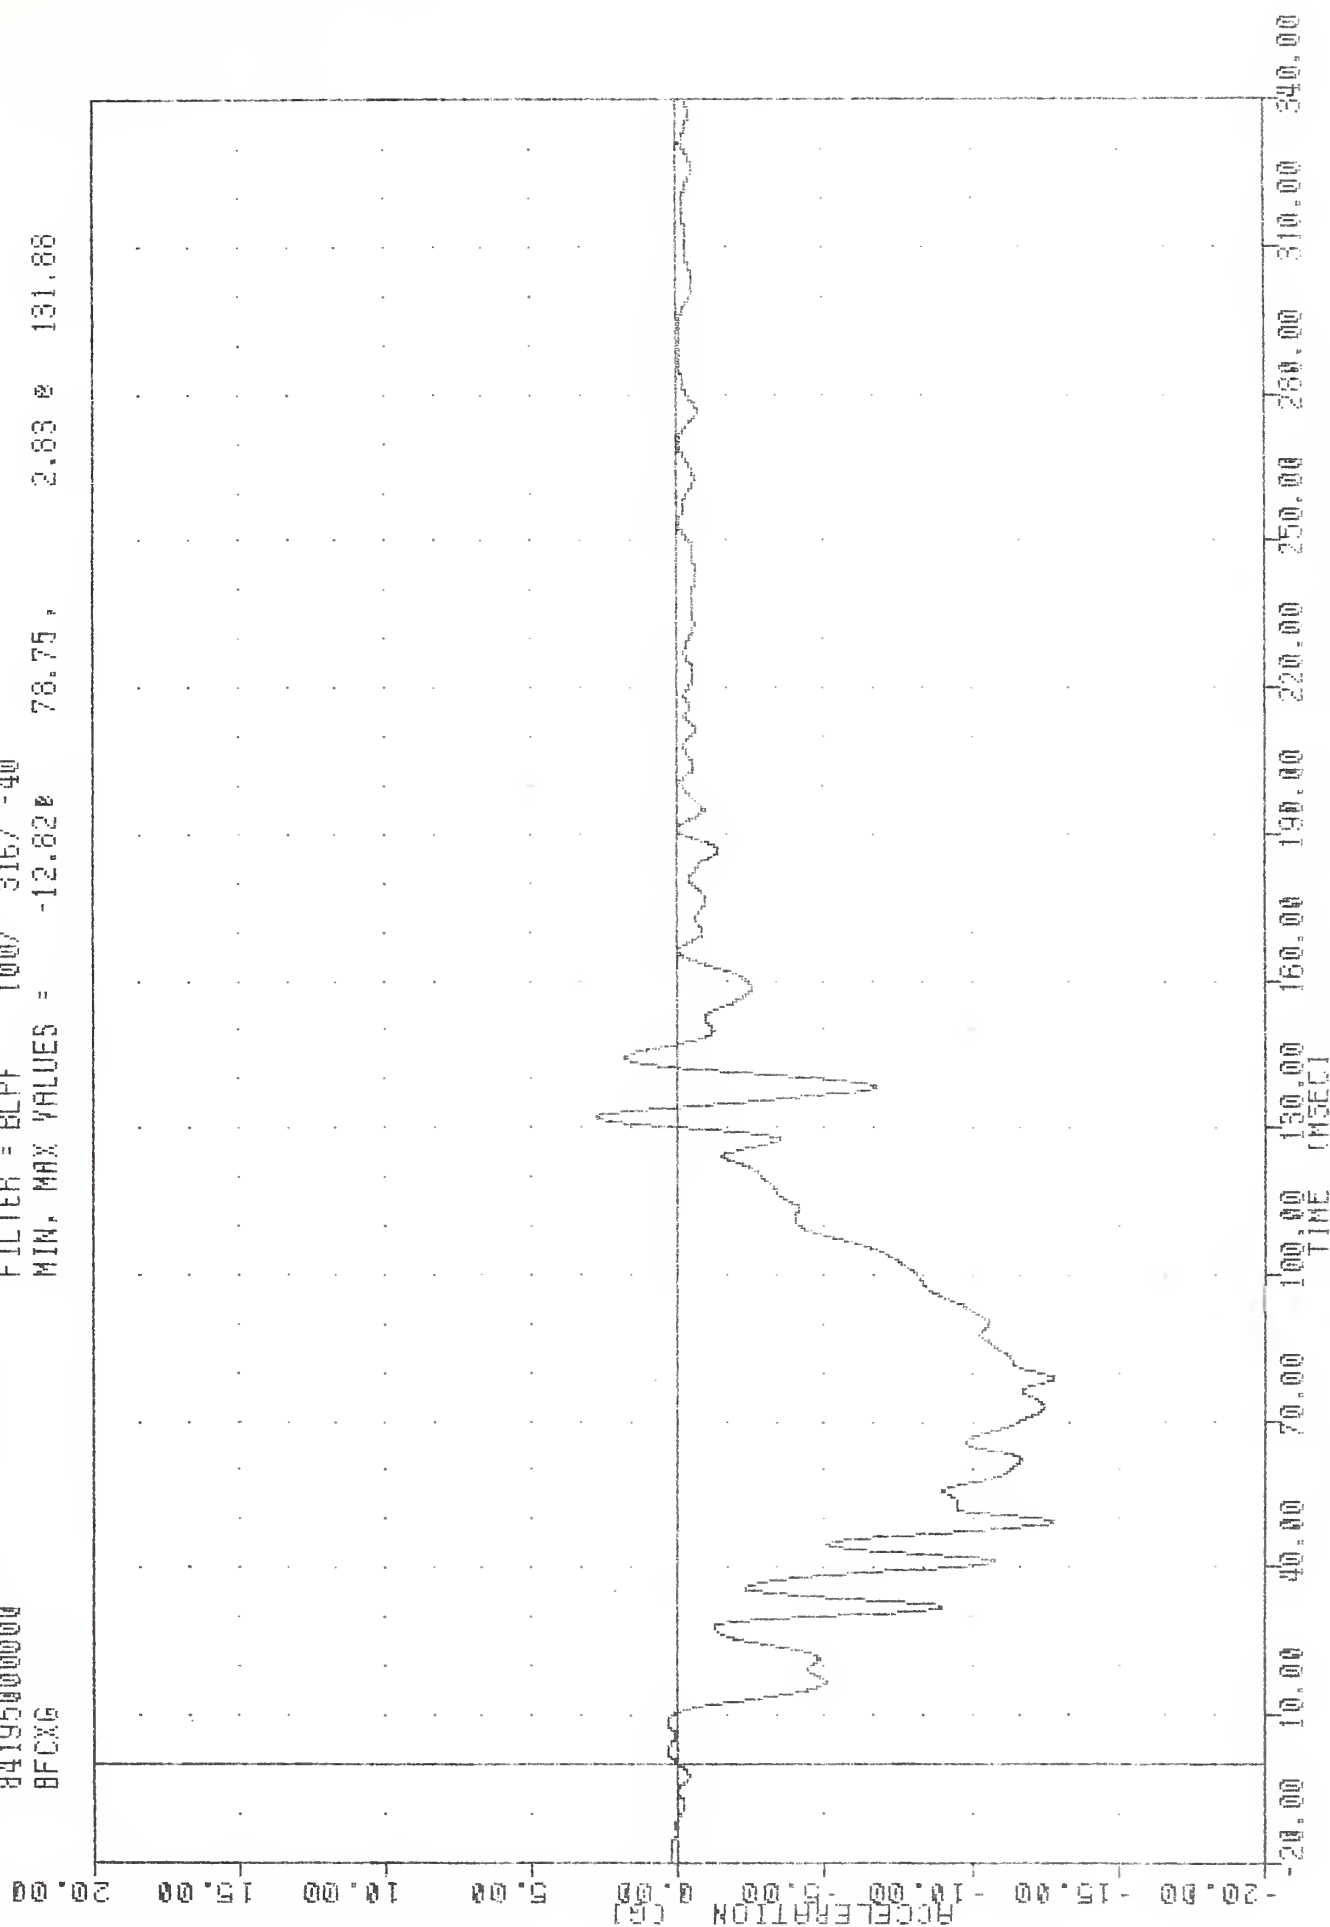
MOVING DEFORMABLE BARRIER INTO VOLKSWAGEN RABBIT
 BARRIER FRONT CROSSMEMBER ACCELERATION X AXIS
